Effect of GapSeal® as a Sealing Material on Microgap and Microleakage at External Hexagon Implant Connections Following Cyclic Loading: An In Vitro Study

Article Type
Original Article

DOI: 10.29252/jrdms.3.3.42

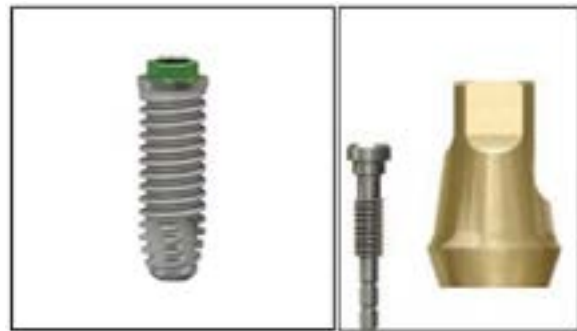
Figure 1- BioHorizons External dental implant (4 mm × 10.5 mm) and abutment with the external-hex connection.

Direct abutments of 6-mm length with collar height of 1 mm were tightened on the fixtures (Figure 1), and then, the assemblies were mounted in a block of translucent auto-polymerizing acrylic resin (Moravia, Boyman Boya, Tokyo, Japan) with a cross-section diameter of 34 mm and a height of 19 mm by a parallelometer (Hahnenkratt, Berlin, Germany).⁽¹⁸⁾

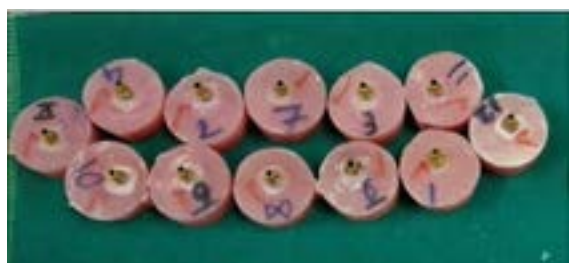
Figure 2. Implant-abutment assemblies mounted in a block of acrylic resin.

In the experimental group, according to the manufacturer's instructions, the interior of the implant was entirely cleaned with alcohol, and then, GapSeal® was applied into the abutments to the maximum capacity to avoid air trapping. Afterward, the abutment screw was tightened on all samples using a digital torque meter (Lutron Electronic Enterprise Co. Ltd., Taipei, Taiwan) by a torque of 30 N/cm.⁽¹⁹⁾ In order to compensate for the settling effect, five minutes later, the abutment screw was once more tightened by the 30-Ncm torque meter (Figure 2)^(18,19)
